2021 Calaveras River Habitat Conservation Plan Annual Report

Stockton East Water District
6767 E. Main Street
Stockton, CA 95215

FISHBIO
1617 S. Yosemite Avenue
Oakdale, CA 953691

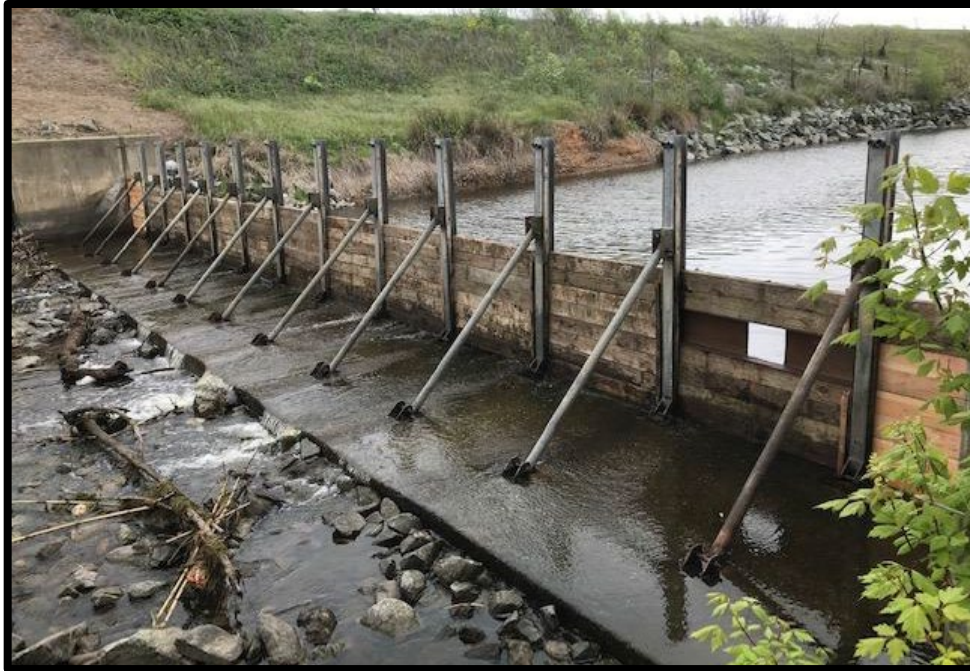
Figure 2. Fish Notch Installation

Fish notches are installed annually in the District’s ten flashboard dams along Mormon Slough. A typical fish passage notch is shown in Figure 2. The flashboard dams were installed in downstream order, with entire reaches of the waterway being completed before installation proceeded to the next reach. Table 2 shows the 2021 flashboard dam installation schedule.

The flashboard dam notches remained in service until May 14, 2021. Rotary screw trap measurements by FISHBIO at the Shelton Road Bridge indicated the last group of Age 1+ out-migrating salmonids most likely passed in April. The District and FISHBIO recommended and NMFS approved closure of the notches by May 14. Correspondence between the District and NMFS approving dam installations and the fish notch closures is included as Attachment 8.

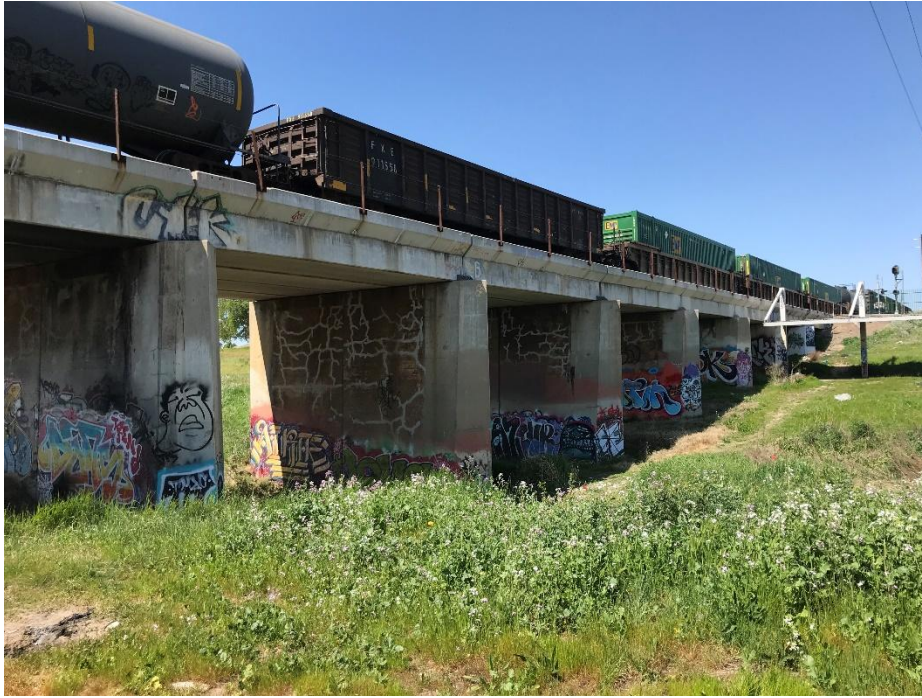
Figure 1. Railroad Bridge

Staff visited the confluence of the Calaveras River and the Diverting Canal (Confluence) and noted two potential locations for flow measurement. The first crossing downstream (Figure 1) of the confluent is a train bridge (Union Pacific) and the second crossing is a city of Stockton pedestrian bridge (Figure 2). The train bridge has power poles parallel to the tracks and could provide a closer hook up to the power, but working with Union Pacific is cumbersome and this location is not preferred.

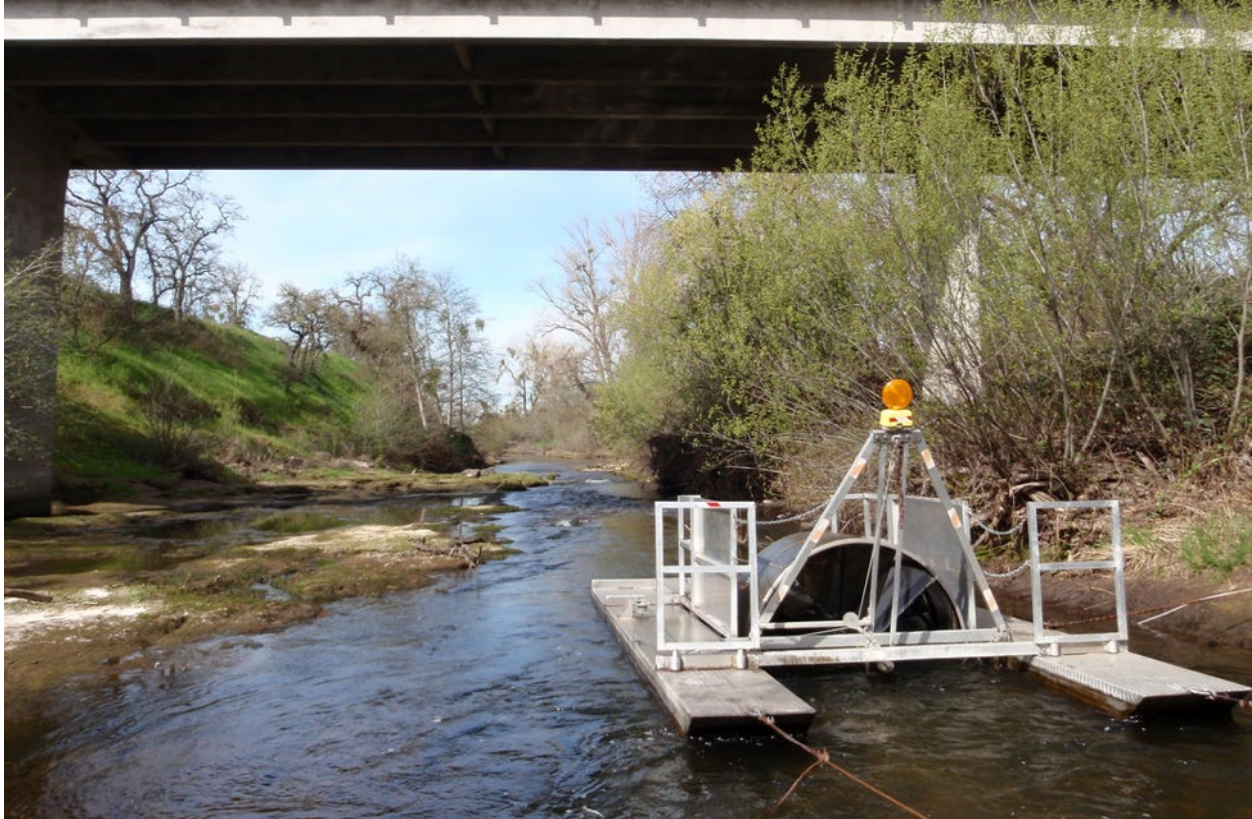
Figure 2. Five-foot diameter rotary screw trap operating during low flows on the Calaveras River at Shelton Road (picture taken on March 17, 2010).

A single 5-ft diameter RST was operated at approximately river mile (RM) 28, just upstream of the Shelton Road bridge (**Figure 1**; **Figure 2**). As described in Palmer and Sonke (2010), flow deflection structures were constructed and strategically placed in the river during lower flow periods in order to divert more water toward the trap, increasing velocity into the funnel for optimal functioning of the trap.

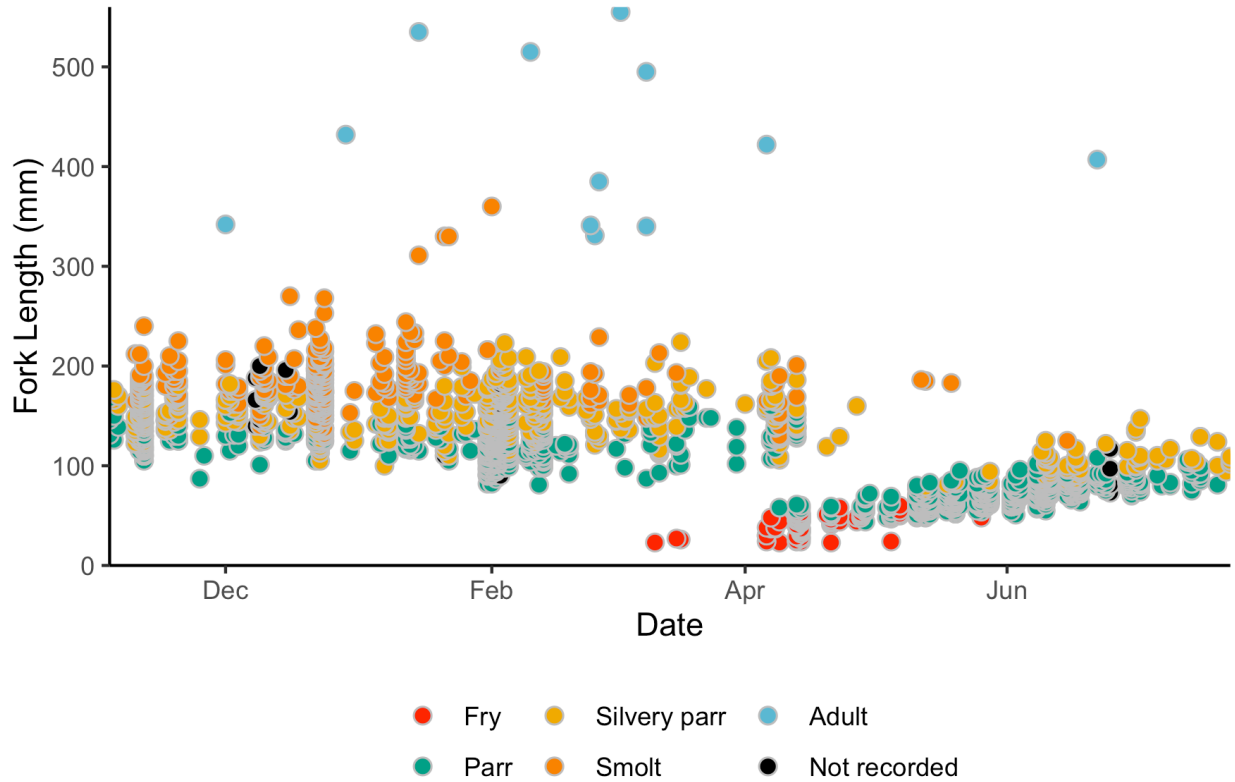
Figure 4. Fork lengths (mm) of all measured *O. mykiss* by date of capture. Color shading indicates life stage.

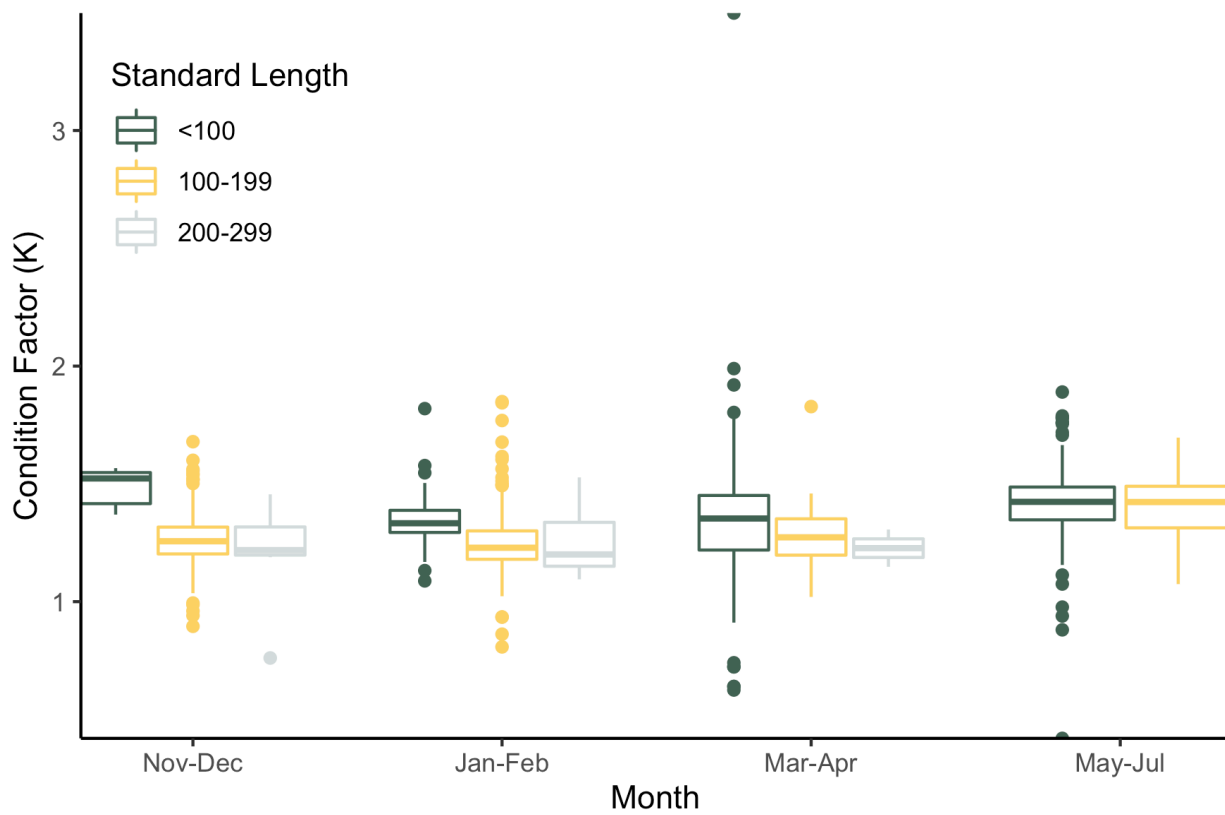
Figure 5. Fulton's condition factor (K) for *O. mykiss* captured in the Shelton Road RST in 2021

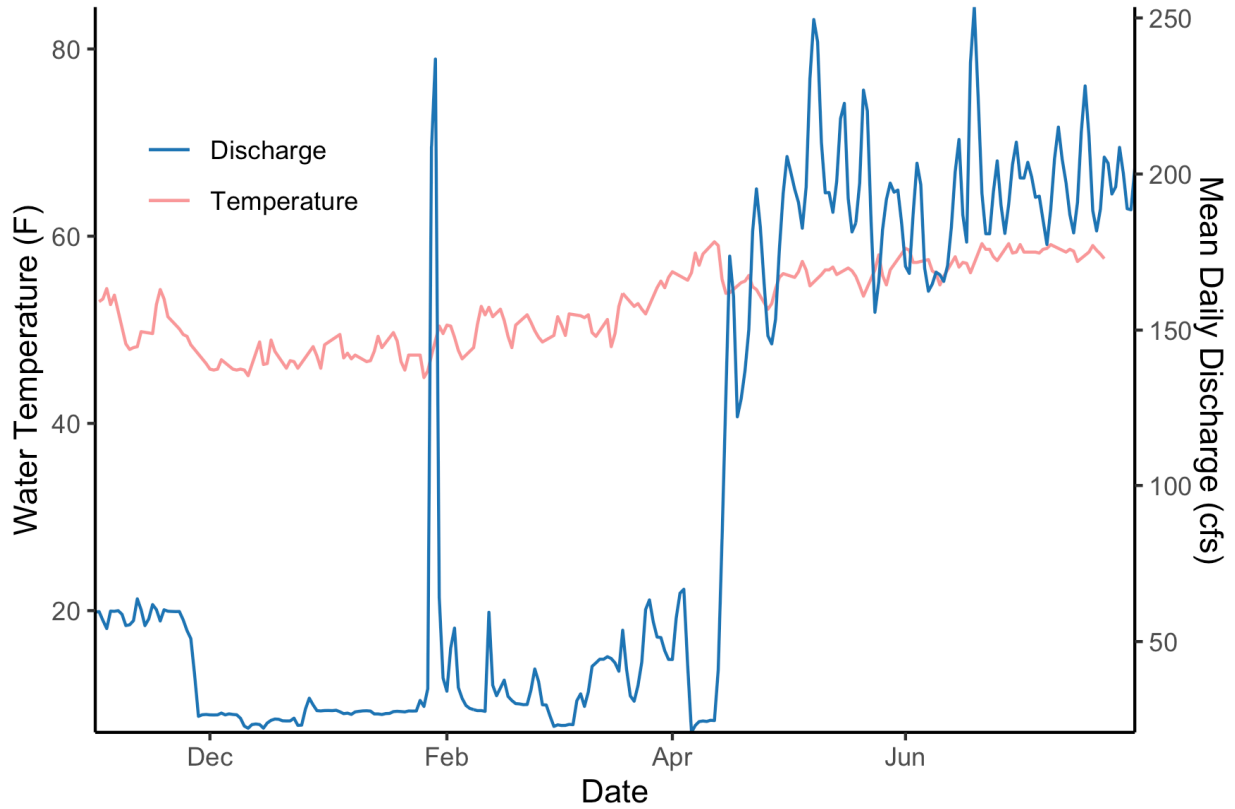
Figure 6. Instantaneous water temperature (°F) measured during daily checks of the Shelton Road RST along with mean daily discharge (cfs).

Daily mean discharge during the trapping period ranged from 21 cfs to 253 cfs. Instantaneous temperatures measured during morning trap checks ranged from 45°F to 59°F (**Figure 6**). Instantaneous measurements of dissolved oxygen ranged from 8.9 mg/L to 13.1 mg/L (**Figure 7**). Lastly, turbidity measured in during morning trap checks ranged from 0.1 NTU to 11.3 NTU (**Figure 8**). A freshet event on January 28, 2021, caused flows from Cosgrove Creek to spike which also caused a spike in turbidity. Additional instantaneous turbidity measurements collected during evening trap checks during the event were as high as 39.7 NTU.

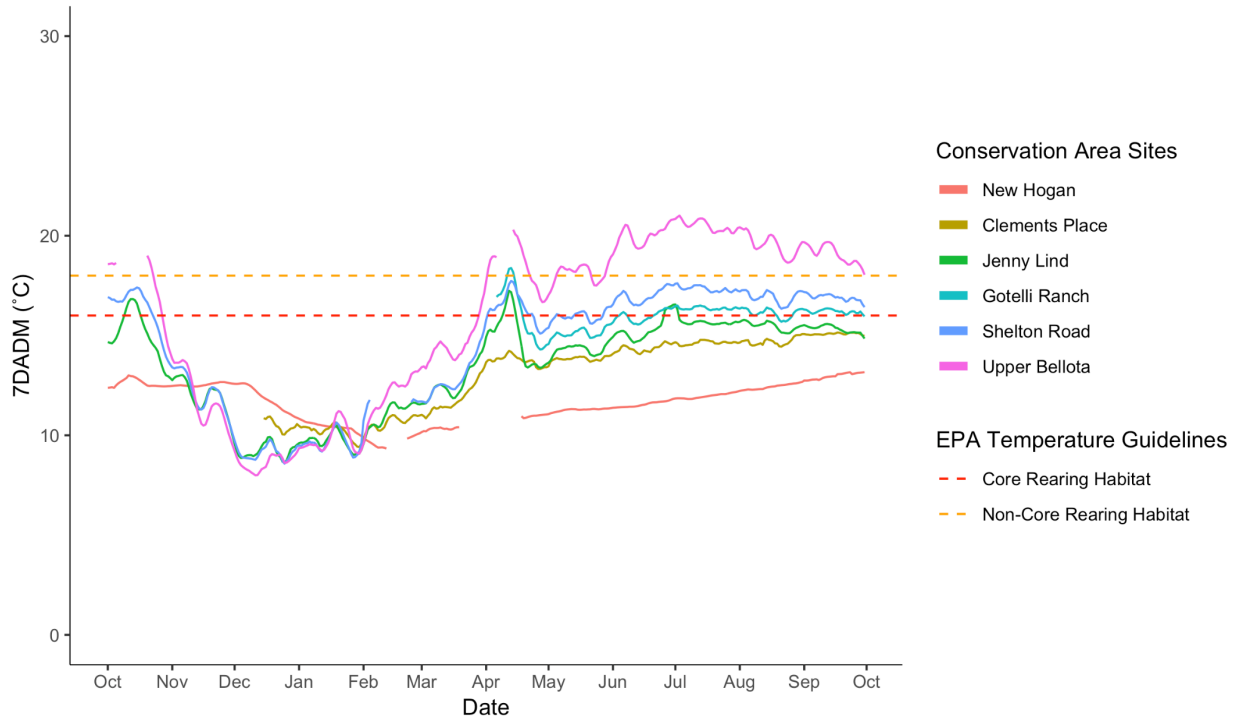
Figure 9. 7-day average daily maximum (7DADM) temperatures as recorded at the six logger sites in the Conservation Area. Gaps in the lines represent periods of missing data that primarily occurred at Gotelli Ranch due to a lost temperature logger (see **Table 8**).

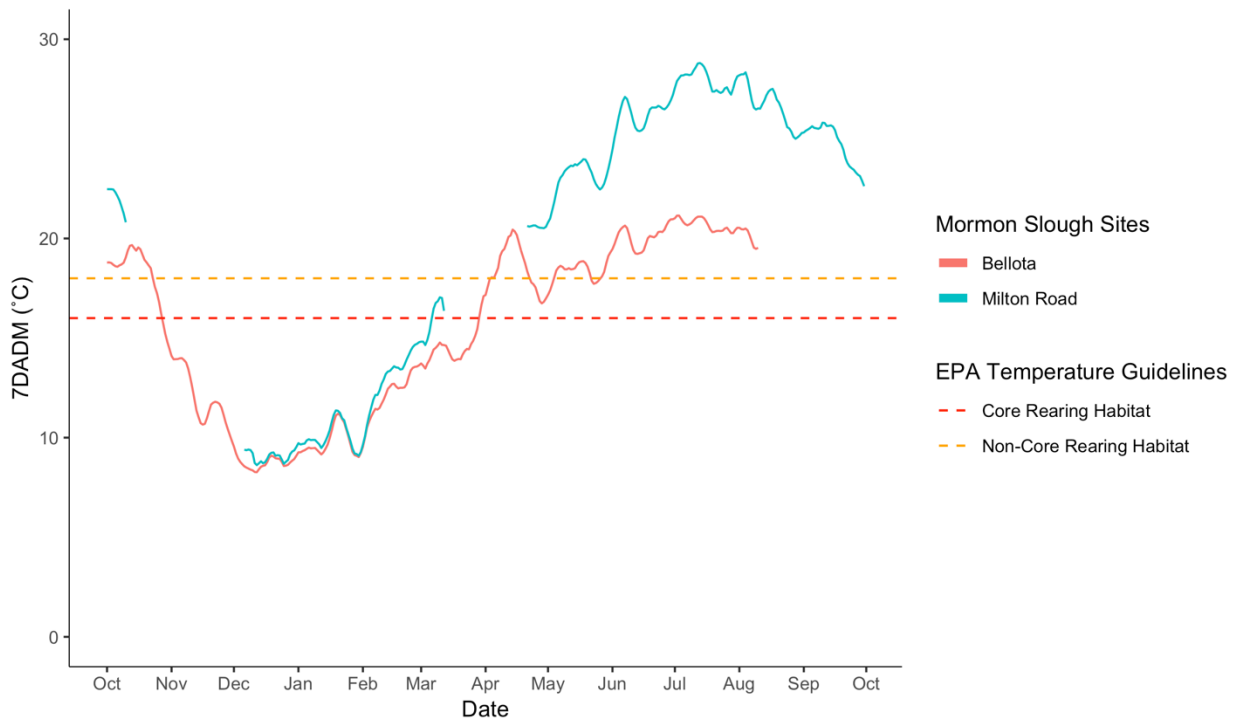
Figure 10. 7-day average daily maximum (7DADM) temperatures as recorded at the two logger sites in Mormon Slough. Gaps in the lines represent periods of missing data (see **Table 8**).

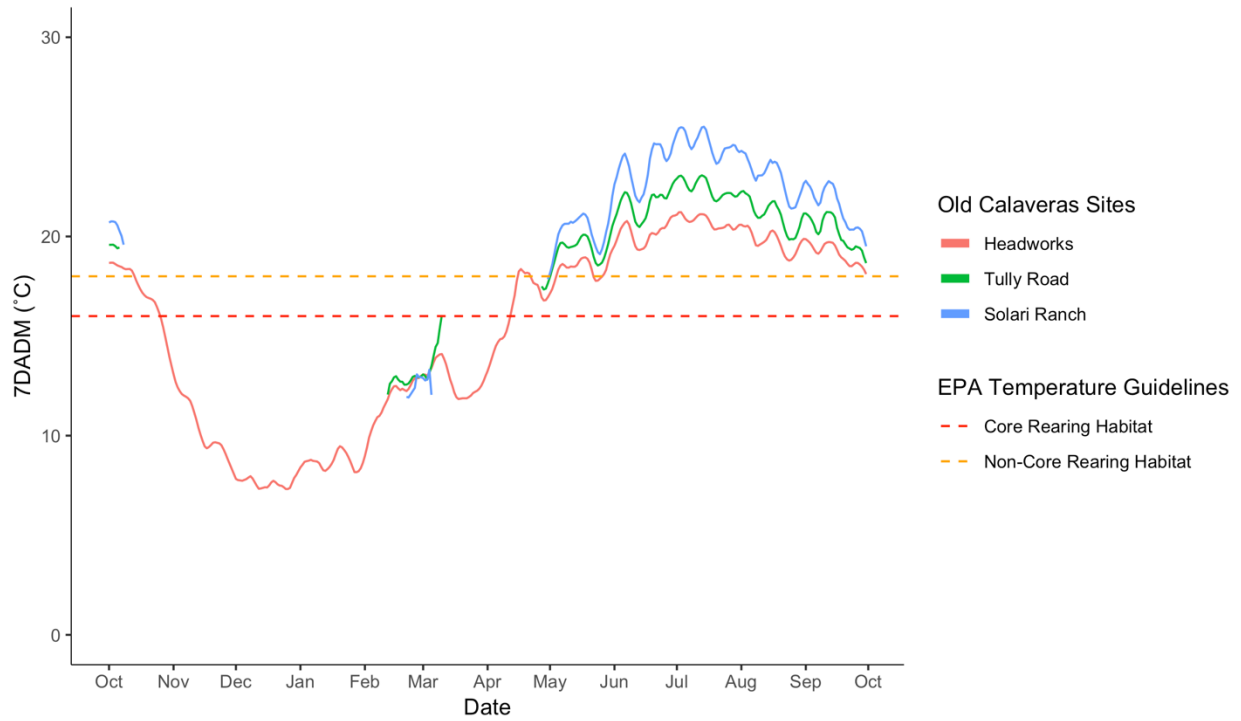
Figure 11. 7-day average daily maximum (7DADM) temperatures as recorded at the three logger sites in the Old Calaveras. Gaps in the lines represent periods of missing data, primarily from dewatering of loggers during the winter and early spring (see **Table 8**).

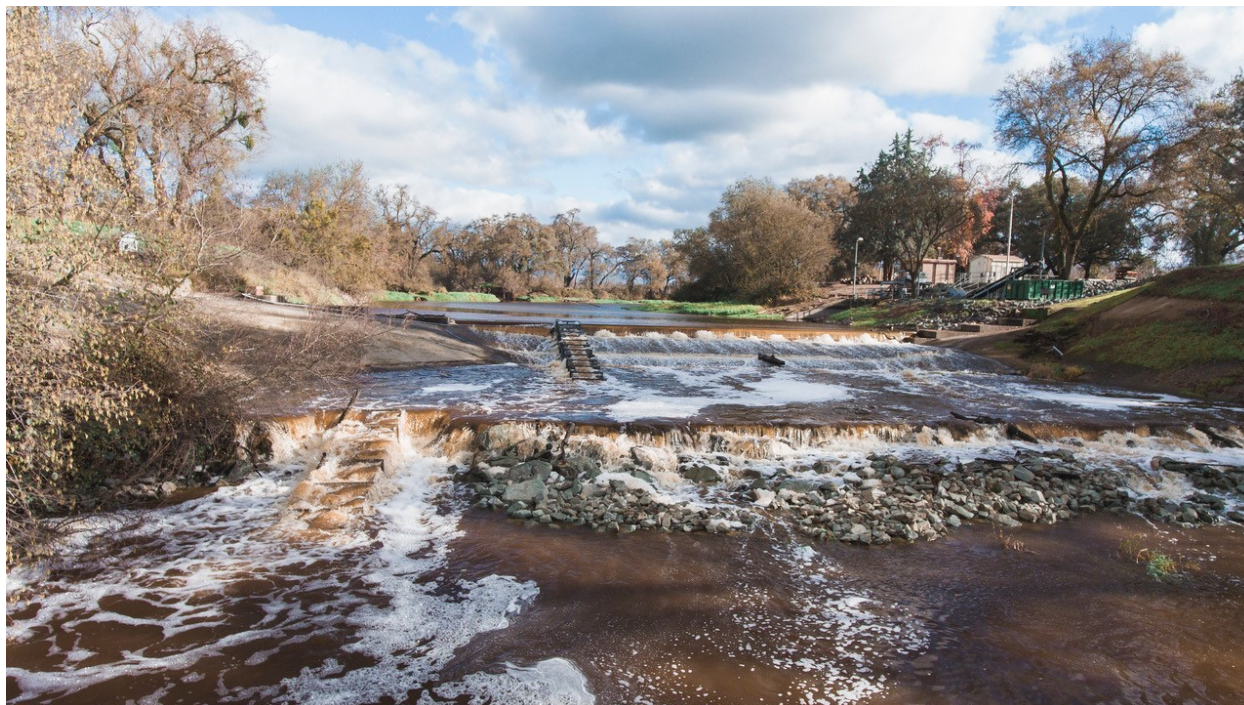
Figure 13. A view of the Bellota Dam structure and the existing two fish ladders looking upstream.

The Bellota Fish Ladder is in the middle reaches of the Calaveras River near the town of Bellota, California. The ladder serves as the primary fish passage structure allowing for access to the upper reaches of the Calaveras River below New Hogan Reservoir. Approximately 150 meters downstream of the confluence of Duck Creek, two flashboard dam structures serve to provide elevation and head pressure for upstream water diversions (**Figure 13**). Under optimal flow conditions, the two flashboard dams are easily passable by migratory fishes such as salmon and steelhead. However, under low flow conditions, habitat above Bellota becomes disconnected as fish are unable to pass without the assistance of the two fish ladders (**Figure 14**). To better understand passage of salmonids through this system FISHBIO has manufactured and installed a camera monitoring system to monitor and enumerate salmonids as they pass through the Bellota Fish Ladder. This report summarizes the results from the video monitoring system and observations of salmonids within the fish ladder during the 2020/2021 field season (e.g., Oct. 22 – Mar. 28).

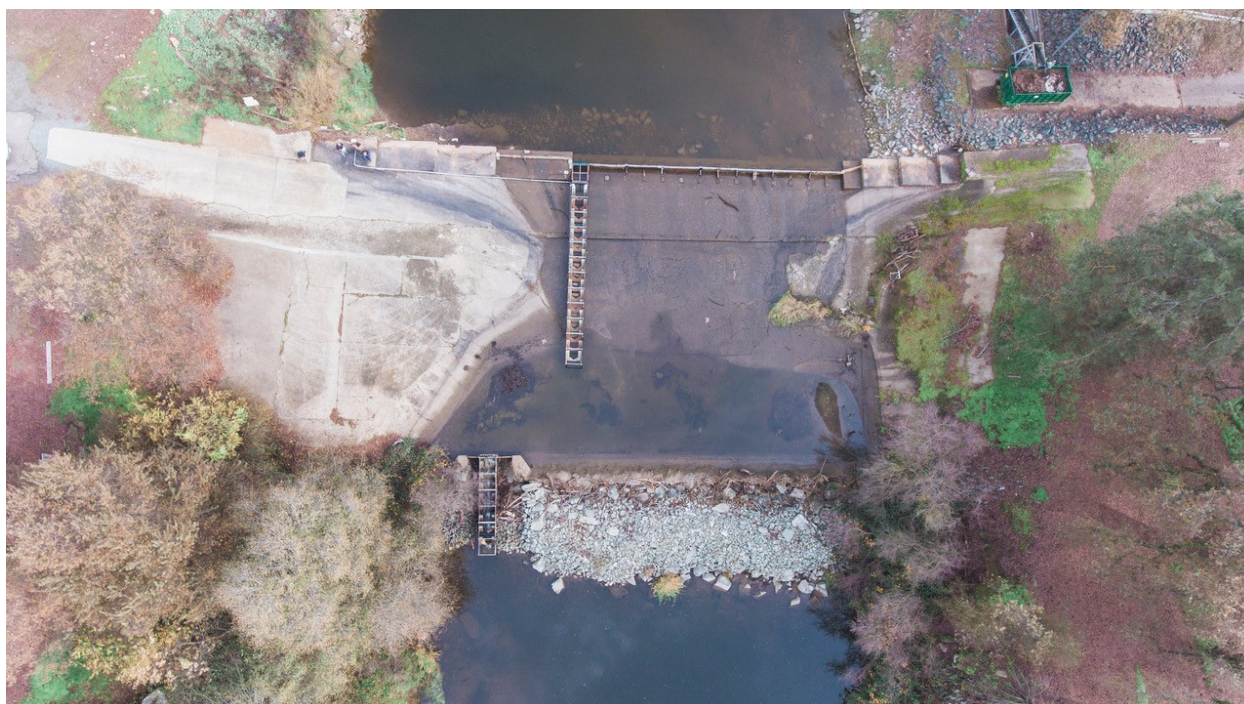
Figure 14. An overhead view of the Bellota Dam and fish ladders under low flow conditions. Note how the lower pool is disconnected from the upper pool preventing fish passage without the assistance of ladders.

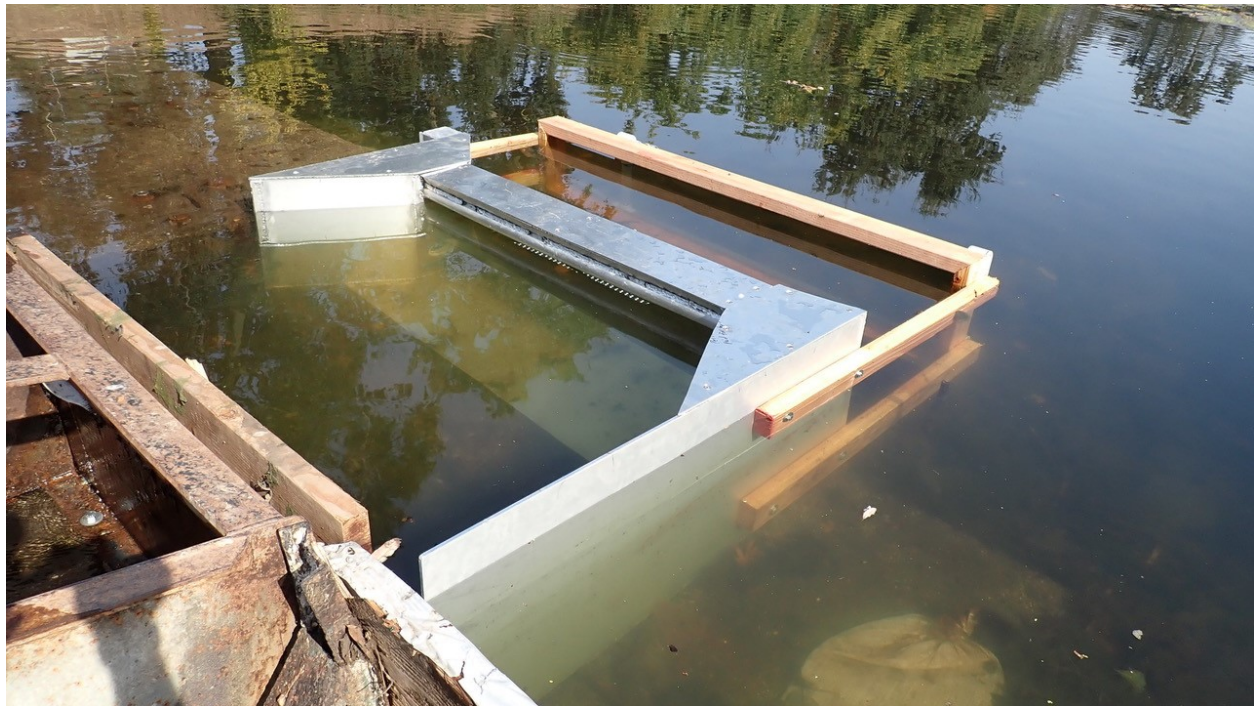
Figure 15. Above photo shows the custom passage chute extending into the upper pool. The chute serves to both extend the ladder to the upper pool while crowding passing fish near the internal cameras to ensure complete coverage.

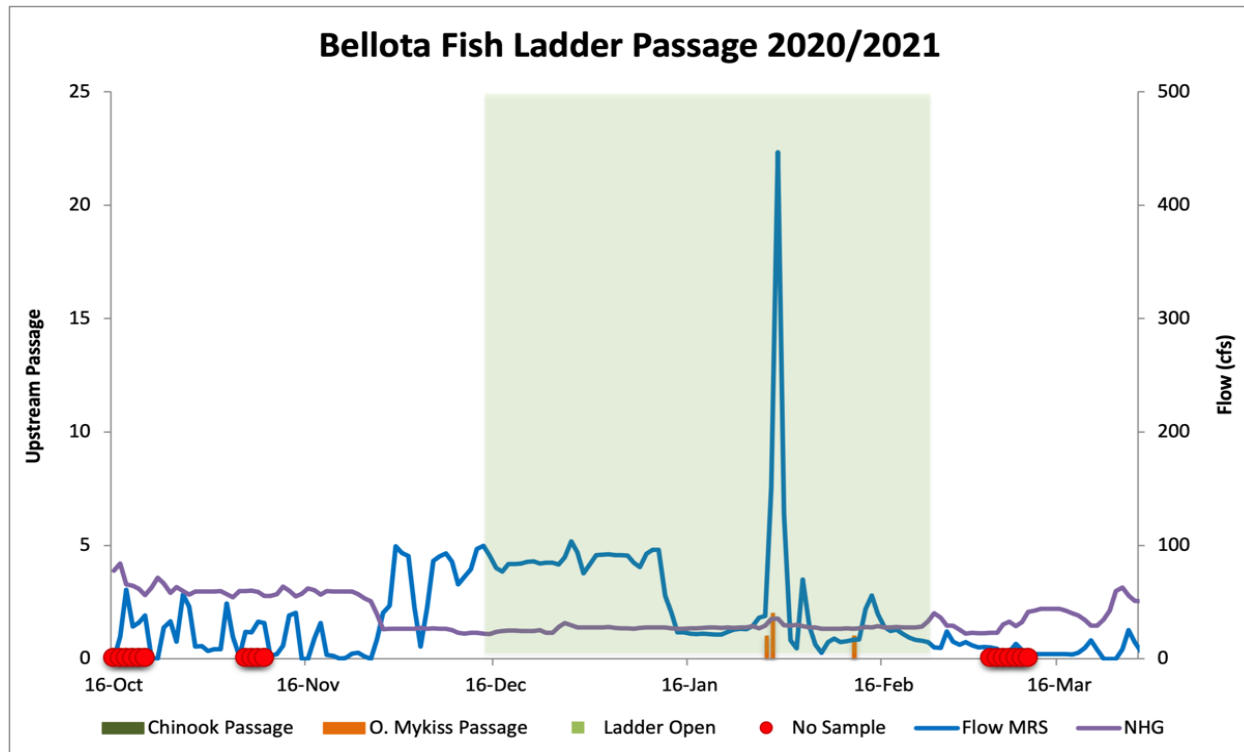
Figure 16. Shows a combined summary of monitoring effort across time on the x-axis. The left y-axis represents the daily fish passage total, indicated by orange bars. The red circles depict periods of when cameras were non-operational. The right y-axis shows the scale of flow measures at two gauging stations: blue is the discharge at the MRS gauging station and purple the NHG gauge included for reference.

beginning on December 14, 2020 and remained operational until February 23, 2021 or 72 days. The video monitoring system was operated during the entire period that the fish ladder was operated (**Figure 16**). During the period of operation only one rain event occurred on January 1, 2021. We observed one major pulse flow of 446 cfs at Mormon Slough (MRS) on January 30, 2021 (**Figure 16**) where fish could possibly pass upstream over the weir without going through the ladder.

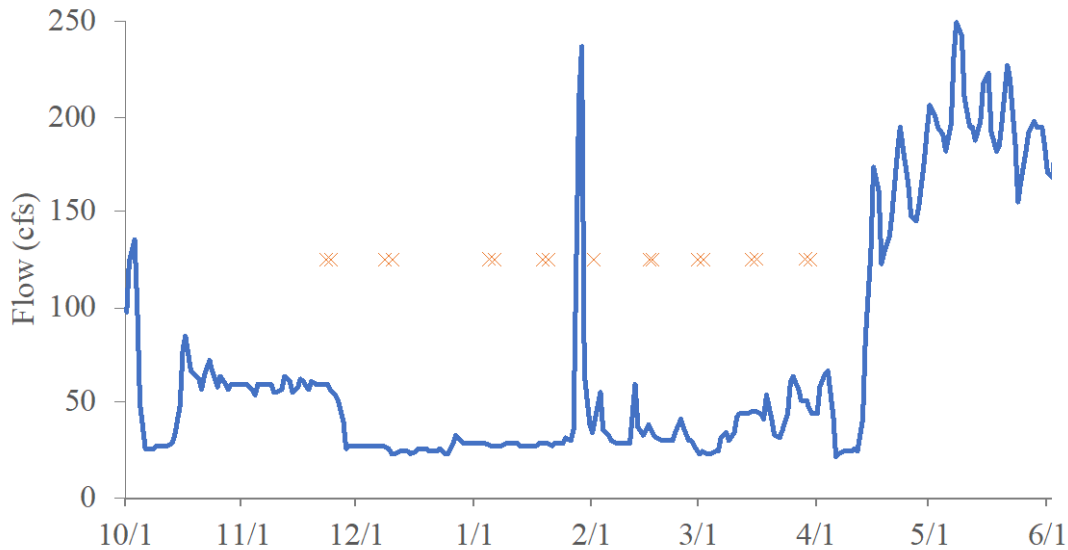
Figure 18. Sample days (orange ‘x’) with Mean daily flow (New Hogan release + Cosgrove Creek) during the 2020/21 redd survey period.

Redd Surveys on the Calaveras River were initiated in late November 2020 and continued approximately bi-weekly through the end of March 2021 (**Figure 18**). Results of an analysis conducted in 2014 of the relationship between emergence timing (inferred from rotary screw trap data, 2002-2013) and water temperature indicated the majority of *O. mykiss* redd construction likely occurs from December to early March (FISHBIO, unpublished report).

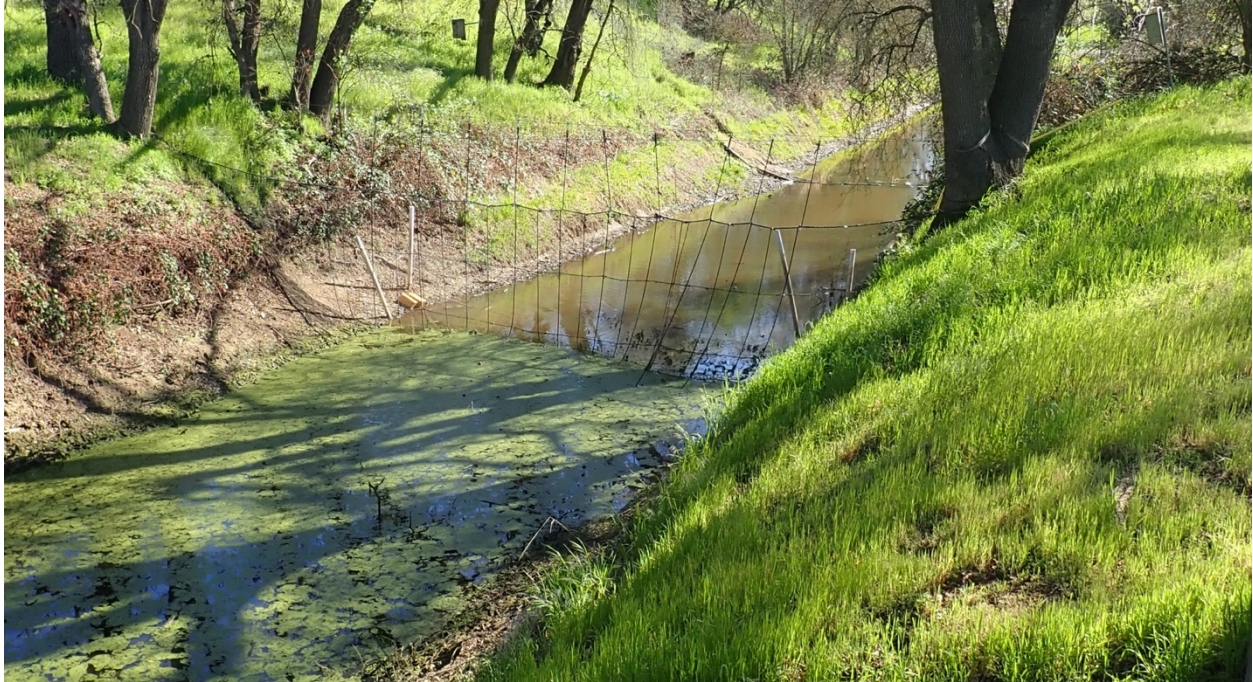
Figure 23. Temporary fish barrier upstream of the Old Calaveras Headworks.

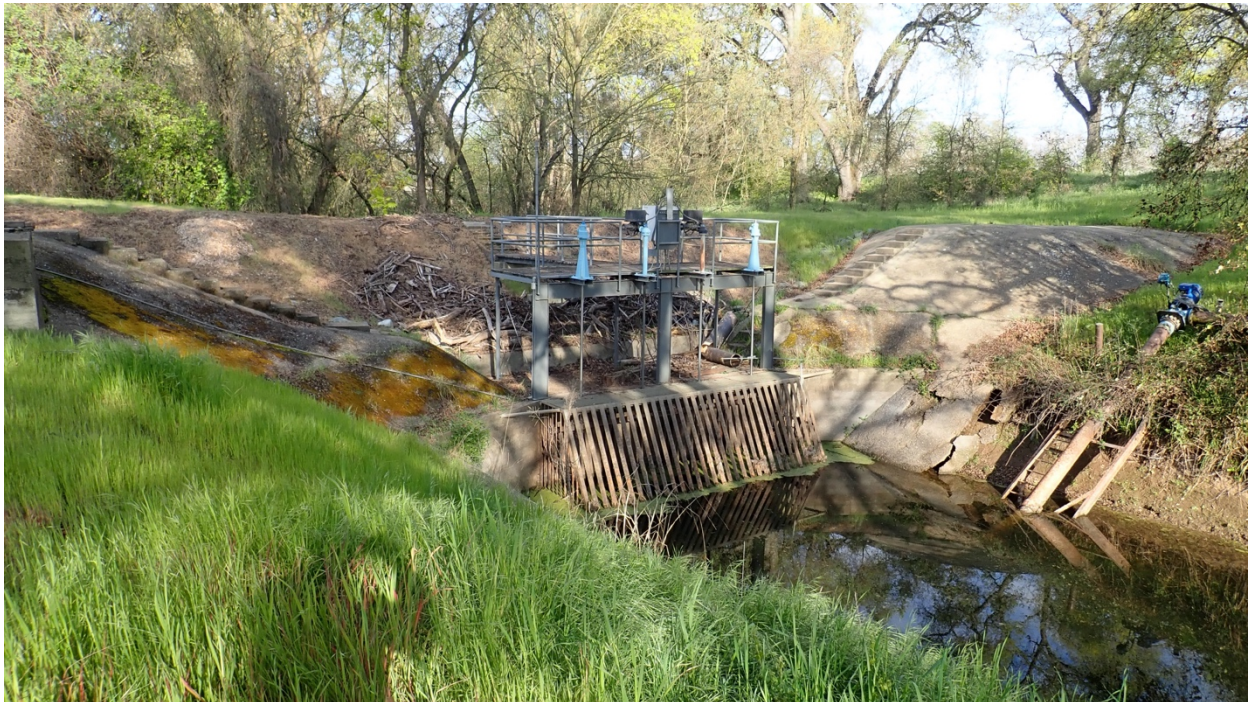
Figure 24. Old Calaveras Headworks structure.

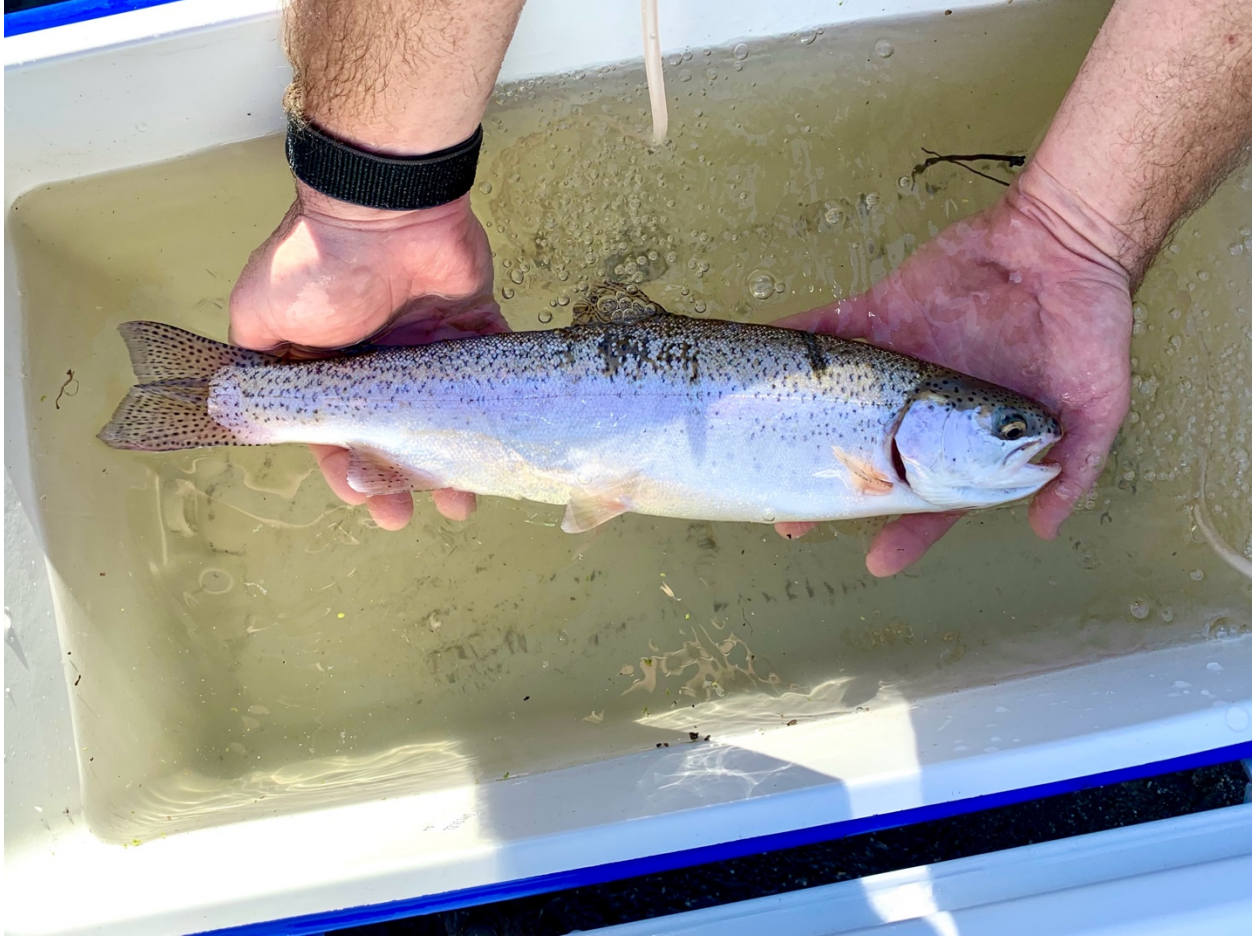
Figure 25. Adult *O. mykiss* measuring 388 mm FL captured at Tully Dam on October 15, 2021.

Flashboard dams were monitored for environmental conditions and for signs of salmonids in distress at seven flashboard dam sites over a period of eleven days. No salmonid mortalities occurred during rescue operations. Seining surveys resulted in 32 *O. mykiss* captured at one location, Tully Dam. Although not required, other native fish including Sacramento pikeminnow, Sacramento sucker, and prickly sculpin were also captured and relocated. Of the 32 *O. mykiss* captured, 31 were age 1+ ranging in fork length 156 mm to 215 mm (mean 182.7 mm) and 1 adult fork length 388 mm was captured (**Figure 25**). Most of the *O. mykiss* captured appeared healthy and in good condition, only one of the age 1+ *O. mykiss* was not measured and tagged because it appeared stressed. It was only scanned for an existing PIT tag and released. Additionally, one of the age 1+ *O. mykiss* was a previously tagged fish, tagged at Shelton Road on June 6, 2021. This suggests that this fish entered the Old Calaveras Channel at some point after early June.

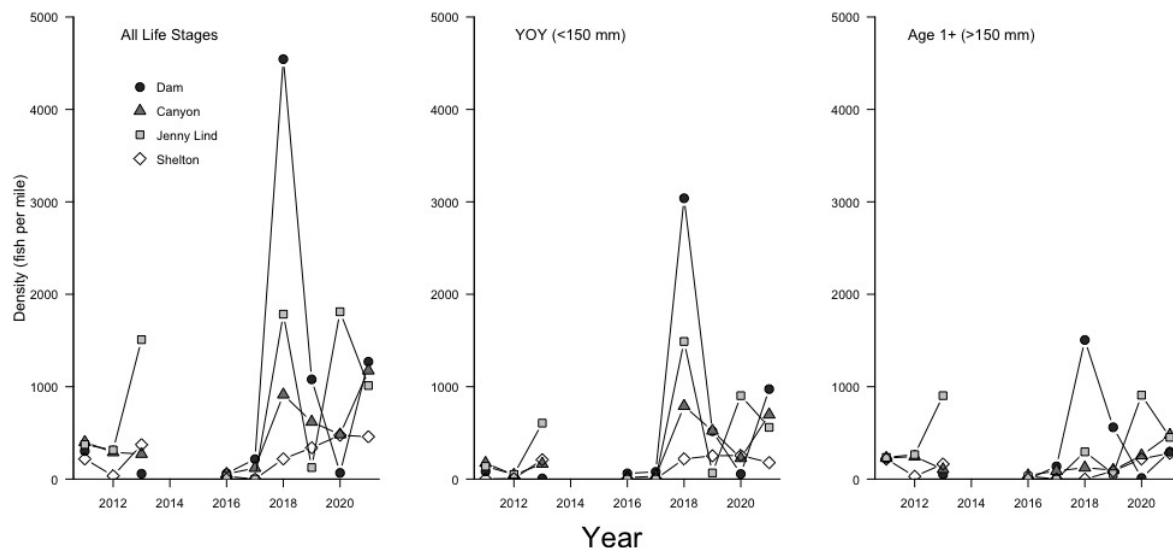
Figure 28. Estimated abundance of *O. mykiss* per mile in each reach during each year of 2011–2021.

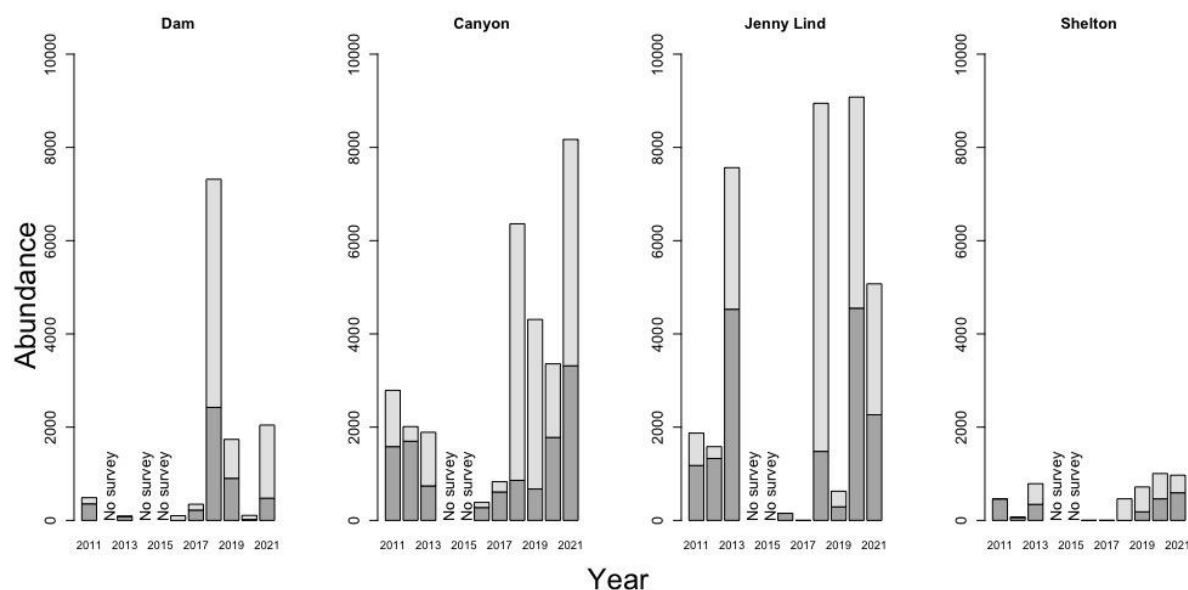
Figure 29. Estimated abundance of *O. mykiss* size classes (light gray: <150 mm; dark gray: >150 mm) in the Calaveras River by survey reach.

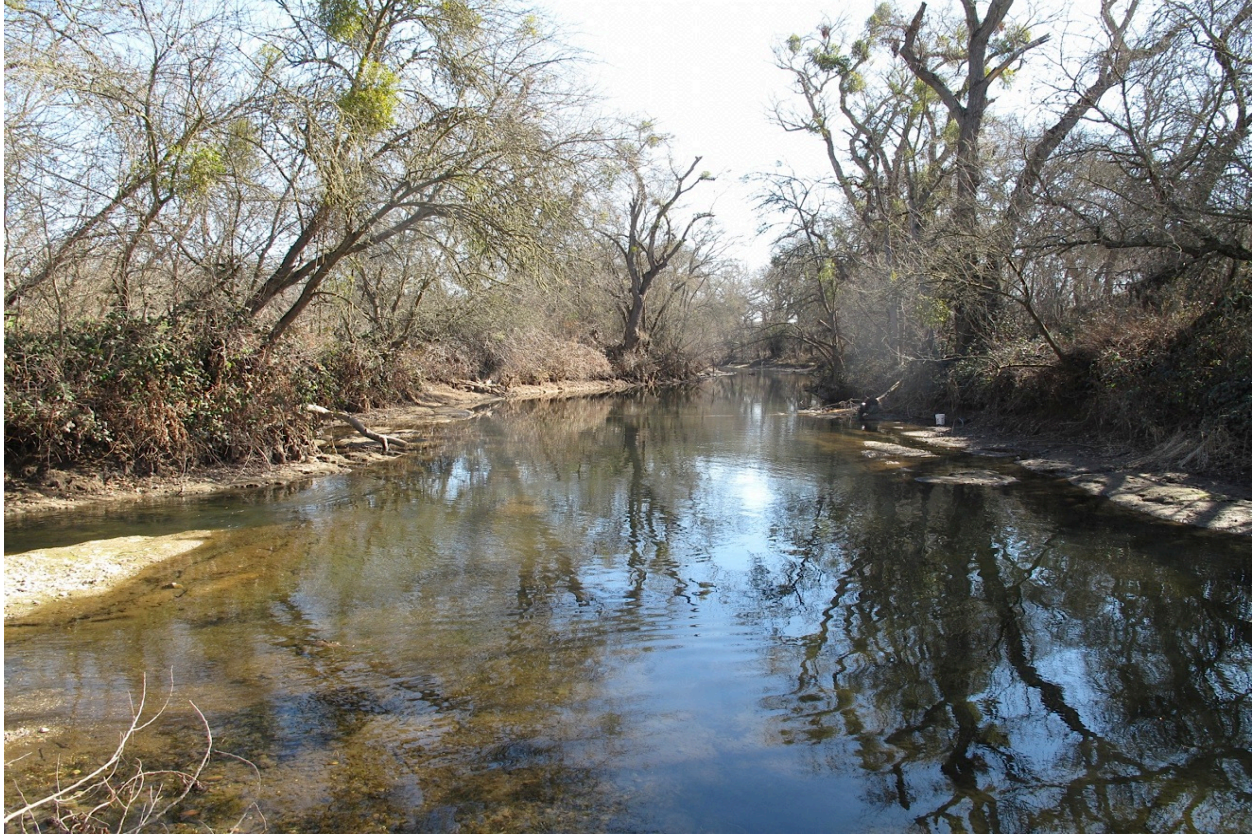
Figure 1. Calaveras River looking upstream from Williams Low Flow Crossing (River Mile 28.5) at the proposed high flow 8-ft. RST site. February 9, 2012; 34 cfs (NHG+COS).
